# SAW Grant

## Storm Water Asset Management and Waste Water

### Awarded in 2015

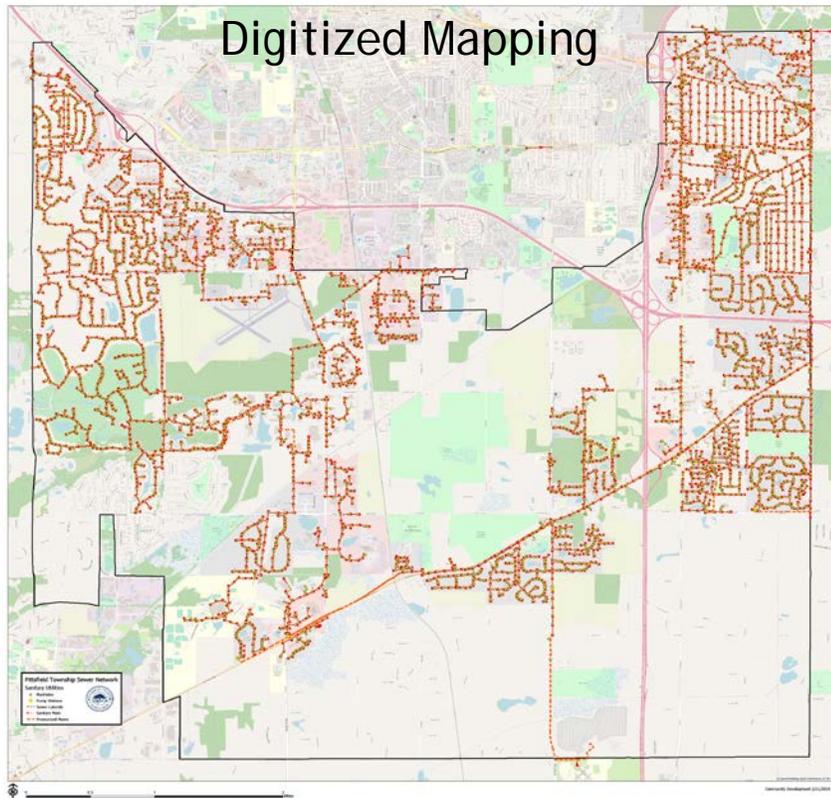
Approximately 150 miles of Sewer Maintained  
Ranging in Sizes from 4" to 36" in Diameter

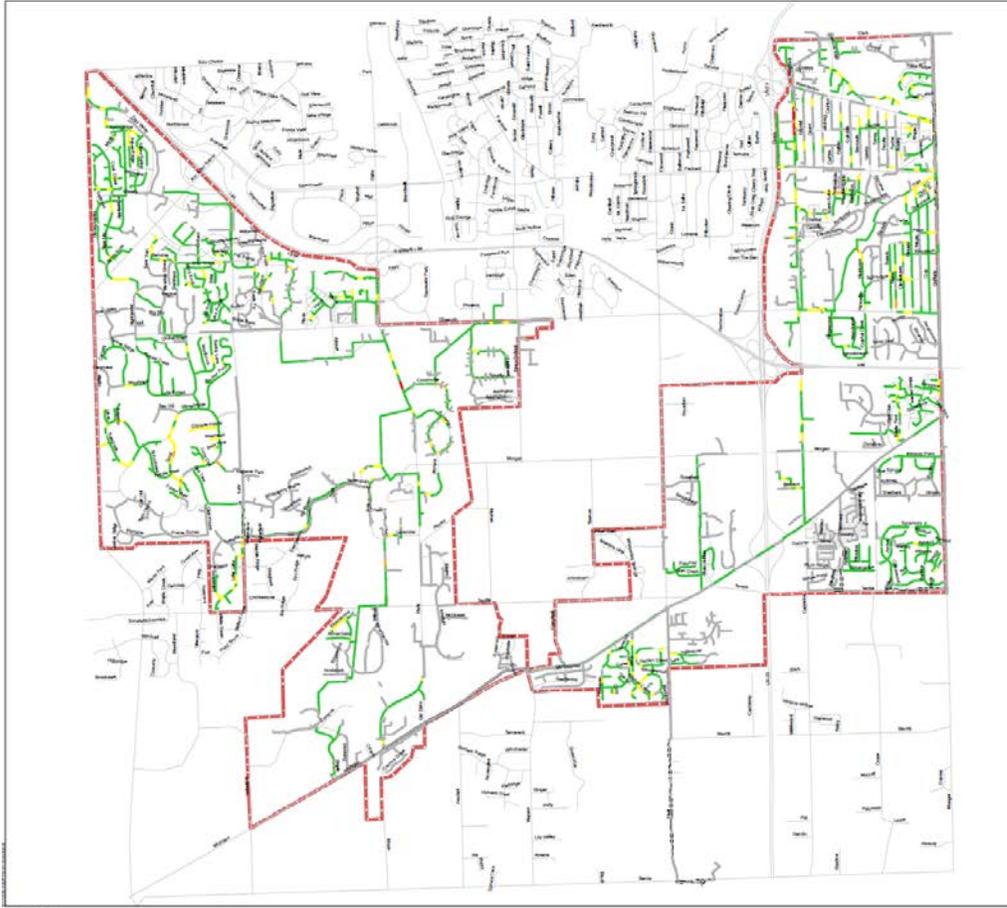
Gravity Sewer Condition Rating	Length	%
1	388,985	55%
2	162,375	23%
3	74,340	11%
4	59,768	8%
5	19,969	3%
<b>Total</b>	<b>705,438</b>	<b>100%</b>
